Manhole Inspection Summary

Manhole # S37MM_037MH

Insp Date: **4/4/07 11:22 AM**

Location Address: **441 22ND ST**

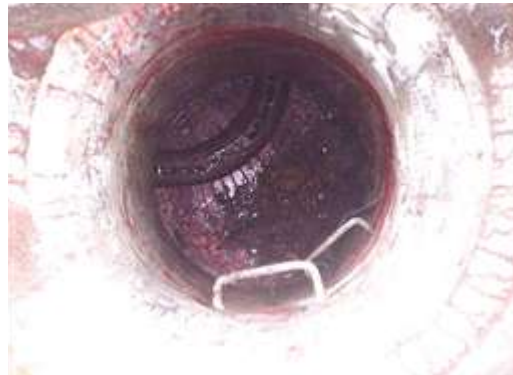
Top View

Adjustment, Corbel and Barrel infiltration. Corroded steps. Evidence of surcharge - Bench debris.

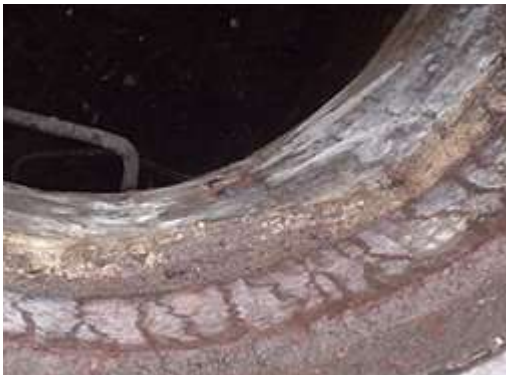
Defect

Frame offset. Adjustment infiltration.

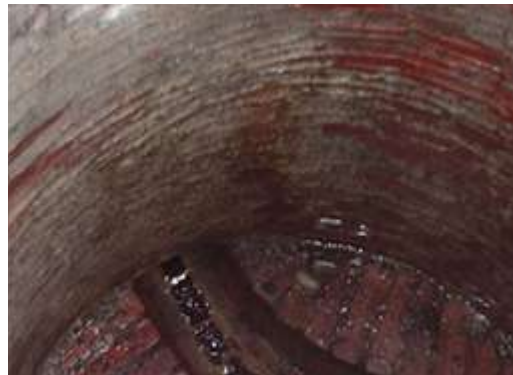
Defect

Barrel infiltration.

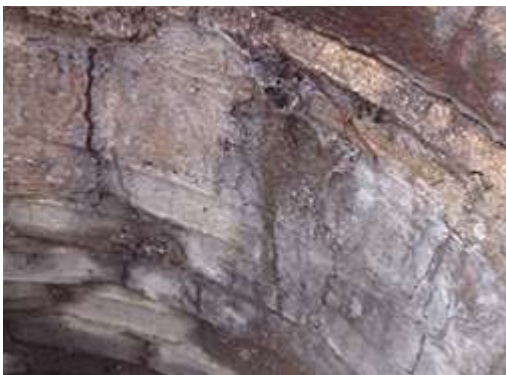
Defect

Frame leaks. Adjustment and Corbel infiltration.

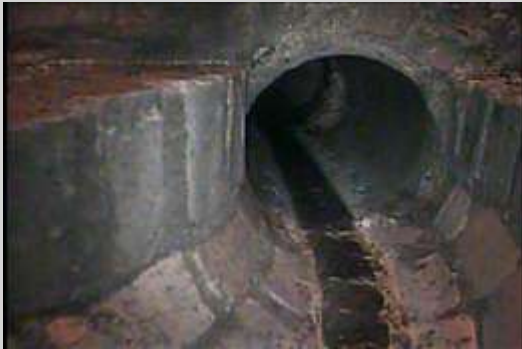
8 in. Circular Gravity Sewer Pipe Out @ 12 O'Clock

Invert Depth: **9.76** (ft.) Flow Characteristics: **Slow**

Infiltration: **None** Pipe Seal Cond: **Unknown**

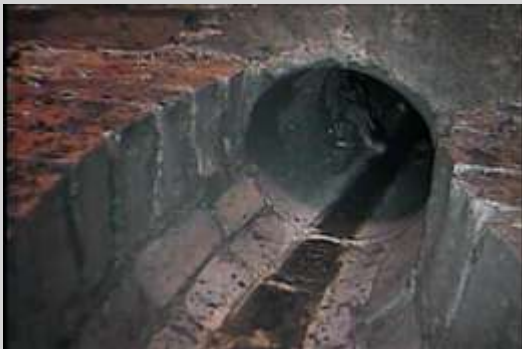
8 in. Circular Gravity Sewer Pipe In @ 9 O'Clock

Invert Depth: **9.61** (ft.) Flow Characteristics: **Slow**

Infiltration: **Evidence** Pipe Seal Cond: **Unknown**
